19118 Mitchell Ave, Rocky River, OH 44116

Report: 64558925

STRUCTURE NUMBER LABELS

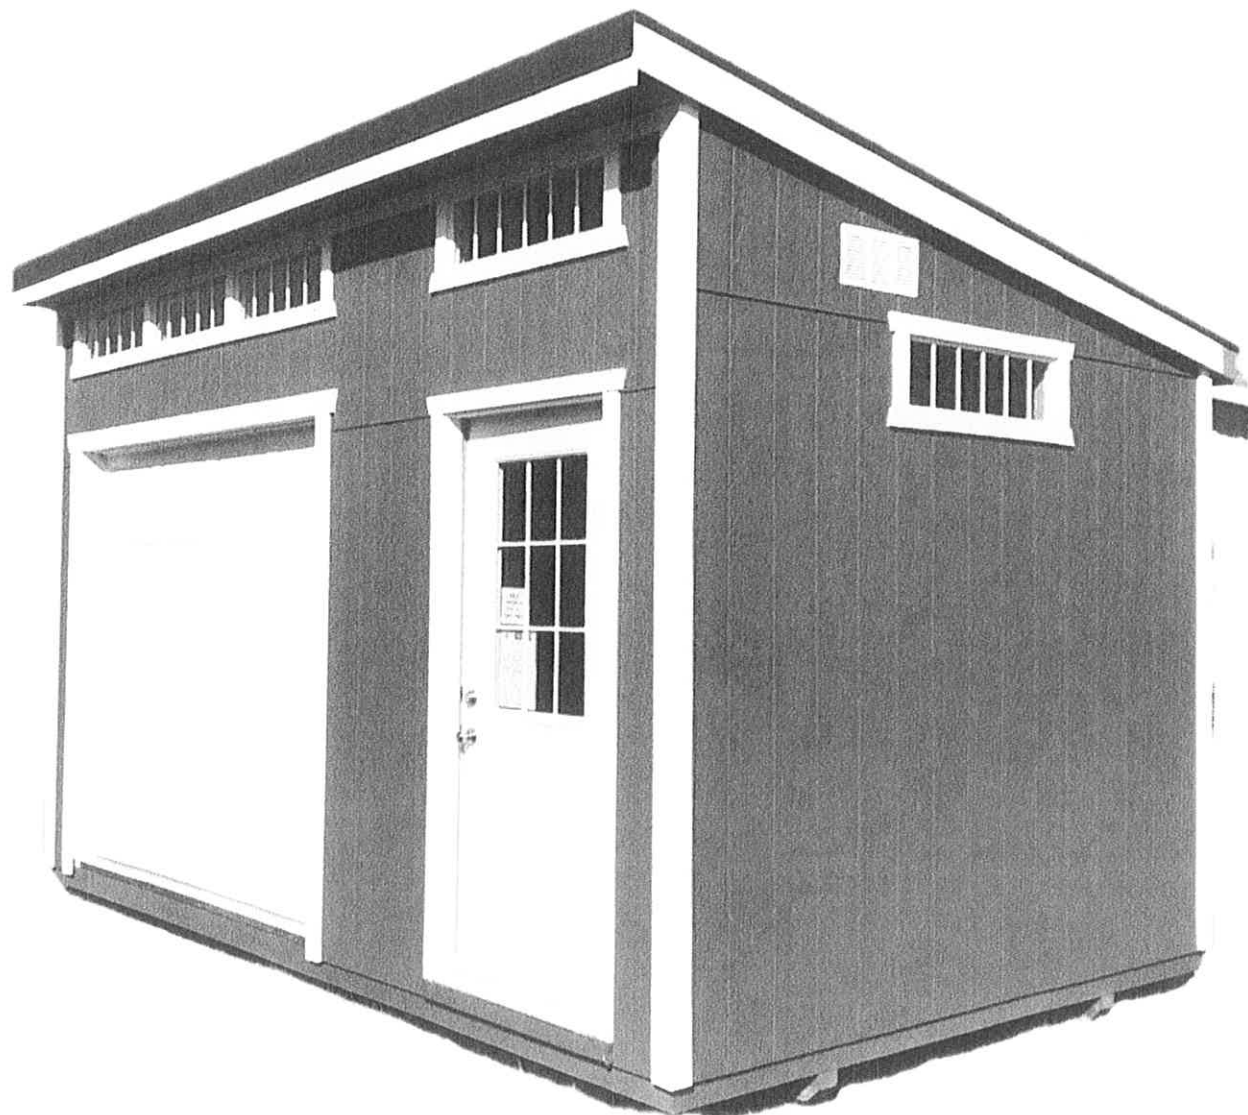
Top Image

IMAGES – TOP VIEW

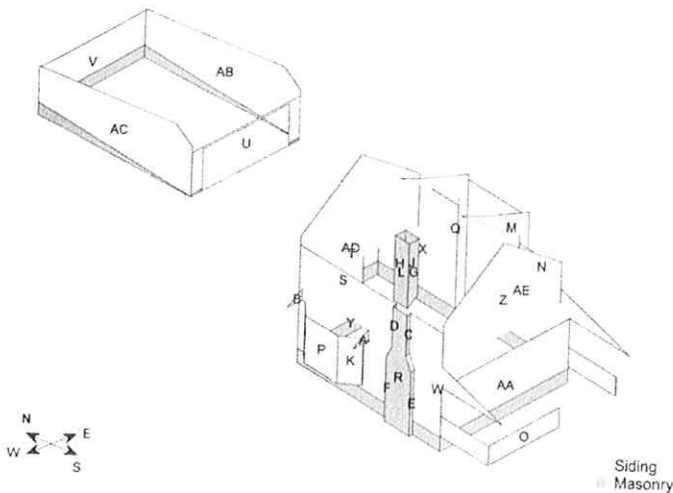
Wall Details

Wall Area including Windows & Doors	=	3530.3 ft ²
Total Siding Area	=	2951.6 ft ²
Total Masonry Area	=	578.7 ft ²

***Calculation Note: Garage door surface areas are subtracted from the total; window and door surface areas are not.**

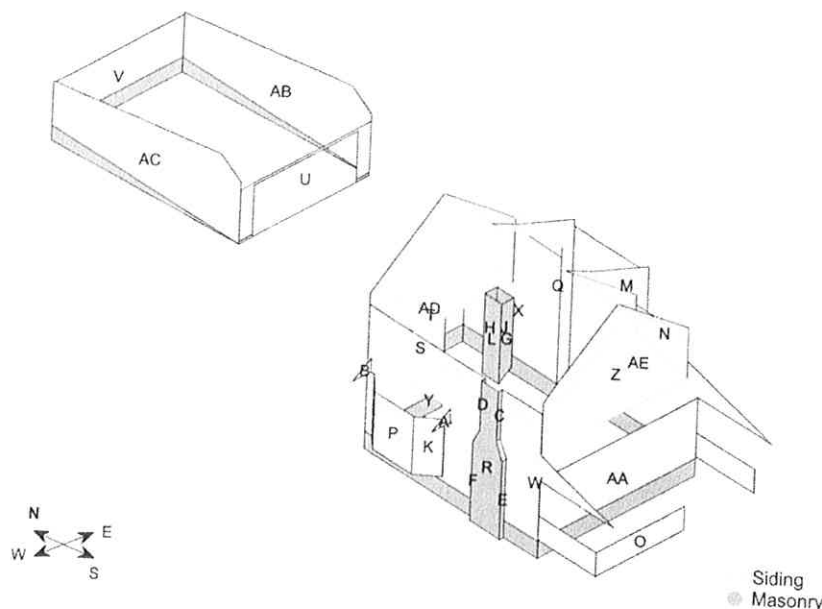
WALL AREA DIAGRAM

Wall	Siding Wall Area (ft ²)	Masonry Wall Area (ft ²)
AD	415.8	28.9
T	101.5	24.9
B	2.7	0.0
F	0.0	7.0
V	116.8	41.8
H	0.0	19.5
D	0.0	4.4
Total	636.8	126.5

Wall	Siding Wall Area (ft ²)	Masonry Wall Area (ft ²)
J	0.0	26.4
X	203.9	36.1
N	36.5	0.0
AE	409.0	48.9
Y	201.5	42.5
AB	253.3	31.3
Total	1104.2	185.2

Wall	Siding Wall Area (ft ²)	Masonry Wall Area (ft ²)
G	0.0	19.5
Z	252.8	0.0
A	2.7	0.0
O	44.4	0.0
Q	59.5	4.4
M	33.5	0.0
AA	201.1	58.2
E	0.0	7.0

Wall	Siding Wall Area (ft ²)	Masonry Wall Area (ft ²)
S	73.7	18.1
K	26.9	0.0
I	26.3	0.0
P	49.7	0.0
L	0.0	30.4
W	151.7	12.8
R	0.0	79.3
AC	253.3	31.3

U	35.0	1.6			
C	0.0	4.4			
Total	629.0	95.1	Total	581.6	171.9

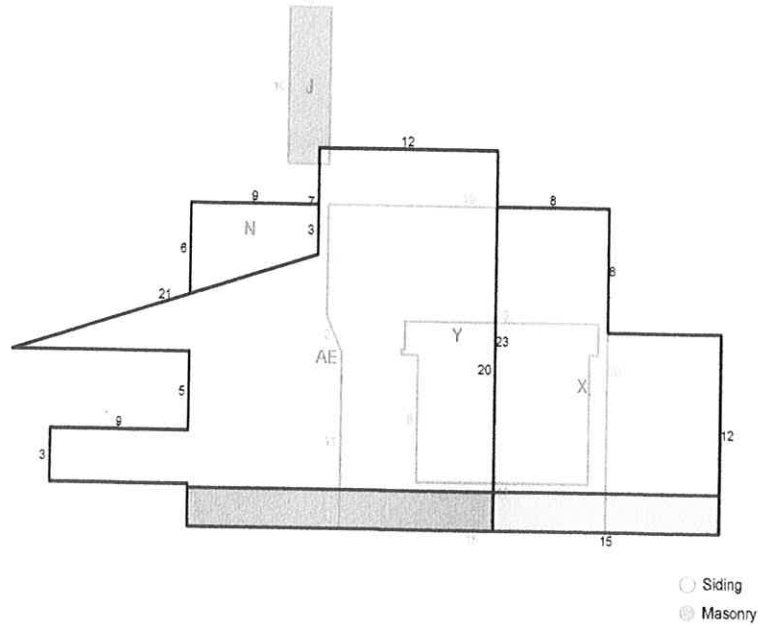
EAST ELEVATION DIAGRAM

Structure #1

Wall	Siding Wall Area (ft ²)	Masonry Wall Area (ft ²)
J	0.0	26.4
X	203.9	36.1
N	36.5	0.0
AE	409.0	48.9
Y	201.5	42.5
Total	850.9	153.9

Note: On-site verification of yellow shaded areas is needed. This diagram shows segment lengths rounded to the nearest whole number. The wall area in square feet (rounded to the nearest tenth) is based on the actual (non-rounded) value of each segment length. Windows and doors have not been subtracted from these measurements.

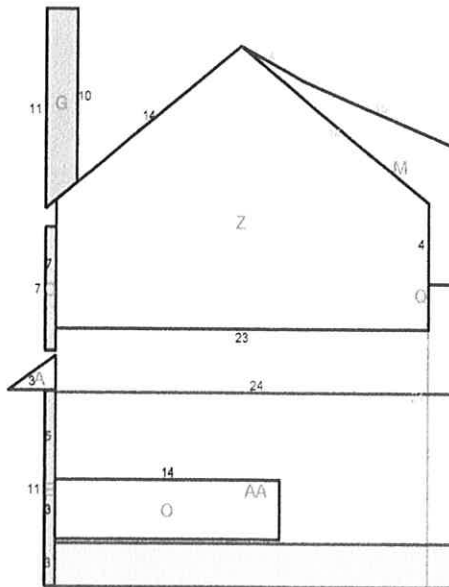
SOUTH ELEVATION DIAGRAM

Structure #1

Wall	Siding Wall Area (ft ²)	Masonry Wall Area (ft ²)
G	0.0	19.5
Z	252.8	0.0
A	2.7	0.0
O	44.4	0.0
Q	59.5	4.4
M	33.5	0.0
AA	201.1	58.2
E	0.0	7.0
C	0.0	4.4
Total	594	93.5

Note: On-site verification of yellow shaded areas is needed. This diagram shows segment lengths rounded to the nearest whole number. The wall area in square feet (rounded to the nearest tenth) is based on the actual (non-rounded) value of each segment length. Windows and doors have not been subtracted from these measurements.

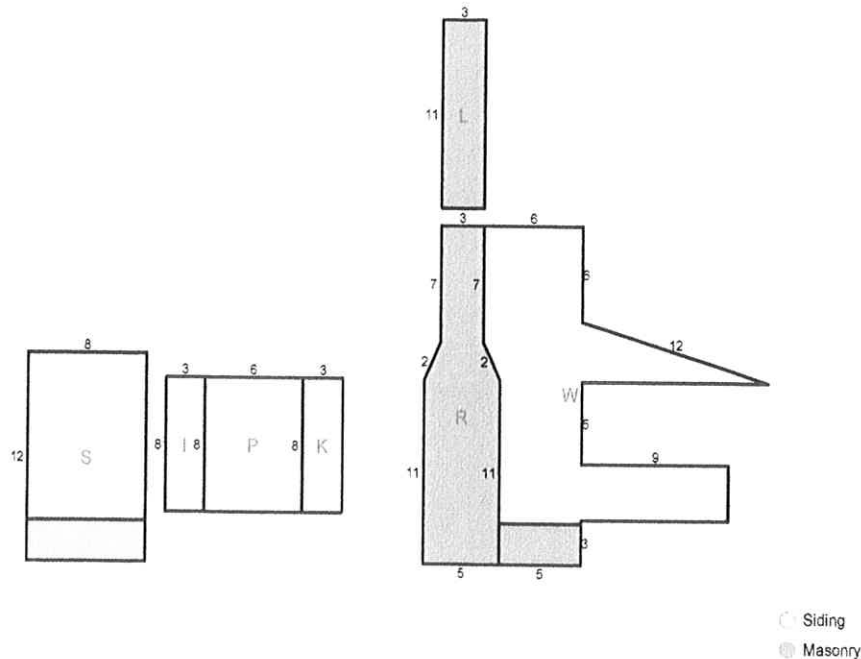
WEST ELEVATION DIAGRAM

Structure #1

Wall	Siding Wall Area (ft ²)	Masonry Wall Area (ft ²)
S	73.7	18.1
K	26.9	0.0
I	26.3	0.0
P	49.7	0.0
L	0.0	30.4
W	151.7	12.8
R	0.0	79.3
Total	328.3	140.6

Note: On-site verification of yellow shaded areas is needed. This diagram shows segment lengths rounded to the nearest whole number. The wall area in square feet (rounded to the nearest tenth) is based on the actual (non-rounded) value of each segment length. Windows and doors have not been subtracted from these measurements.

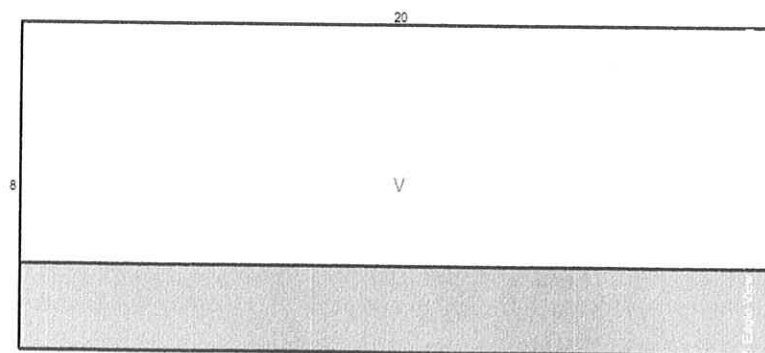
NORTH ELEVATION DIAGRAM

Structure #2

Wall	Siding Wall Area (ft ²)	Masonry Wall Area (ft ²)
V	116.8	41.8
Total	116.8	41.8

Note: On-site verification of yellow shaded areas is needed. This diagram shows segment lengths rounded to the nearest whole number. The wall area in square feet (rounded to the nearest tenth) is based on the actual (non-rounded) value of each segment length. Windows and doors have not been subtracted from these measurements.

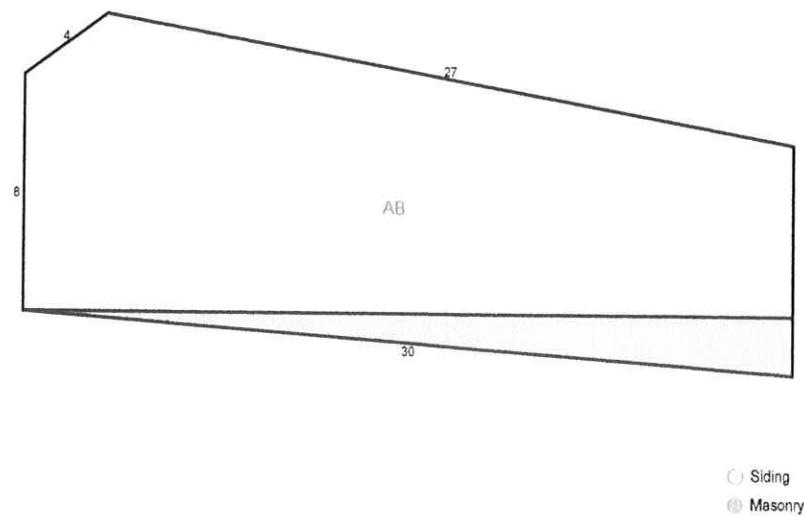
EAST ELEVATION DIAGRAM

Structure #2

Wall	Siding Wall Area (ft ²)	Masonry Wall Area (ft ²)
AB	253.3	31.3
Total	253.3	31.3

Note: On-site verification of yellow shaded areas is needed. This diagram shows segment lengths rounded to the nearest whole number. The wall area in square feet (rounded to the nearest tenth) is based on the actual (non-rounded) value of each segment length. Windows and doors have not been subtracted from these measurements.

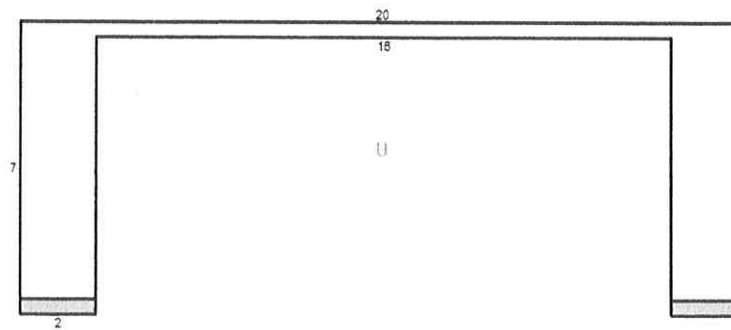
SOUTH ELEVATION DIAGRAM

Structure #2

Wall	Siding Wall Area (ft ²)	Masonry Wall Area (ft ²)
U	35.0	1.6
Total	35	1.6

Note: On-site verification of yellow shaded areas is needed. This diagram shows segment lengths rounded to the nearest whole number. The wall area in square feet (rounded to the nearest tenth) is based on the actual (non-rounded) value of each segment length. Windows and doors have not been subtracted from these measurements.

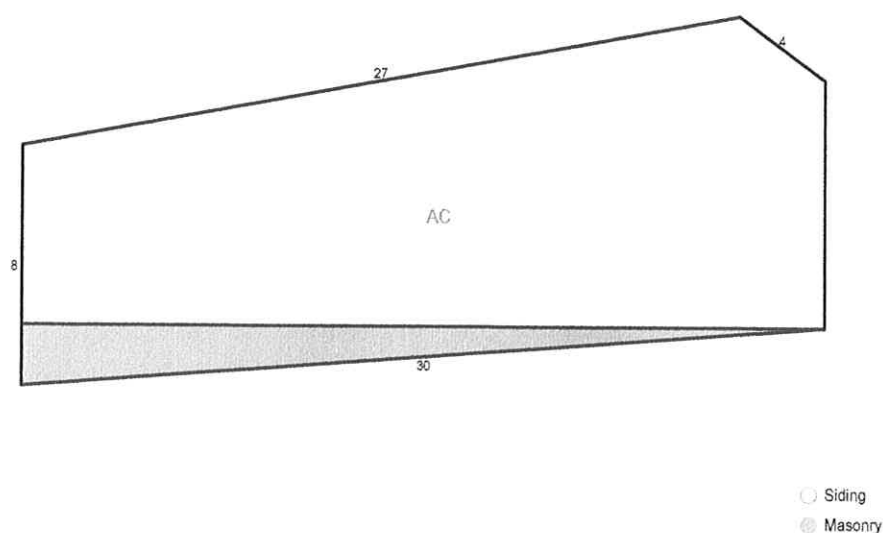
WEST ELEVATION DIAGRAM

Structure #2

Wall	Siding Wall Area (ft ²)	Masonry Wall Area (ft ²)
AC	253.3	31.3
Total	253.3	31.3

Note: On-site verification of yellow shaded areas is needed. This diagram shows segment lengths rounded to the nearest whole number. The wall area in square feet (rounded to the nearest tenth) is based on the actual (non-rounded) value of each segment length. Windows and doors have not been subtracted from these measurements.

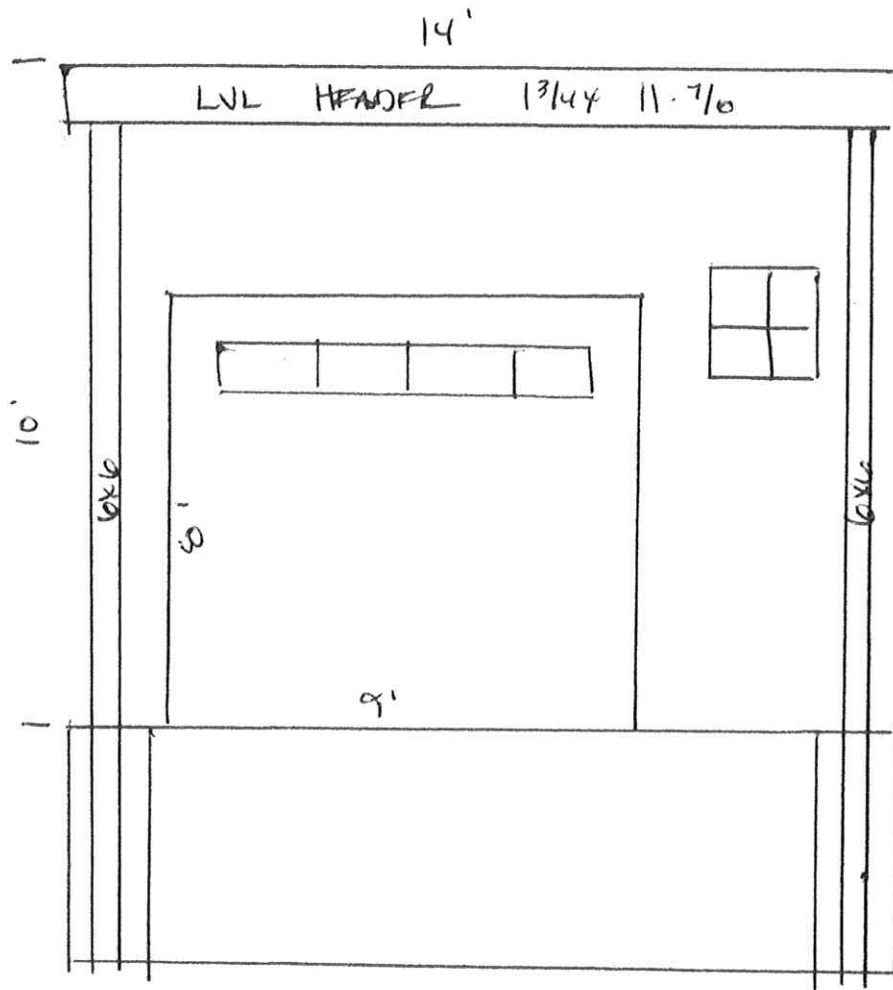
HANDERS SIMPSON / LDC
BOTH SIDES BEAMS
2x6
